TEST OF AN ELECTROHYDRAULIC DIGITAL ACTUATOR FOR ADVANCED MISSILE SYSTEMS

TECHNICAL REPORT AFWAL-TR-80-2001

Final Report for Period September 1978 - September 1979

BENDIX RESEARCH LABORATORY
REPORT OF REACTION PIN SPACER
FAILURE

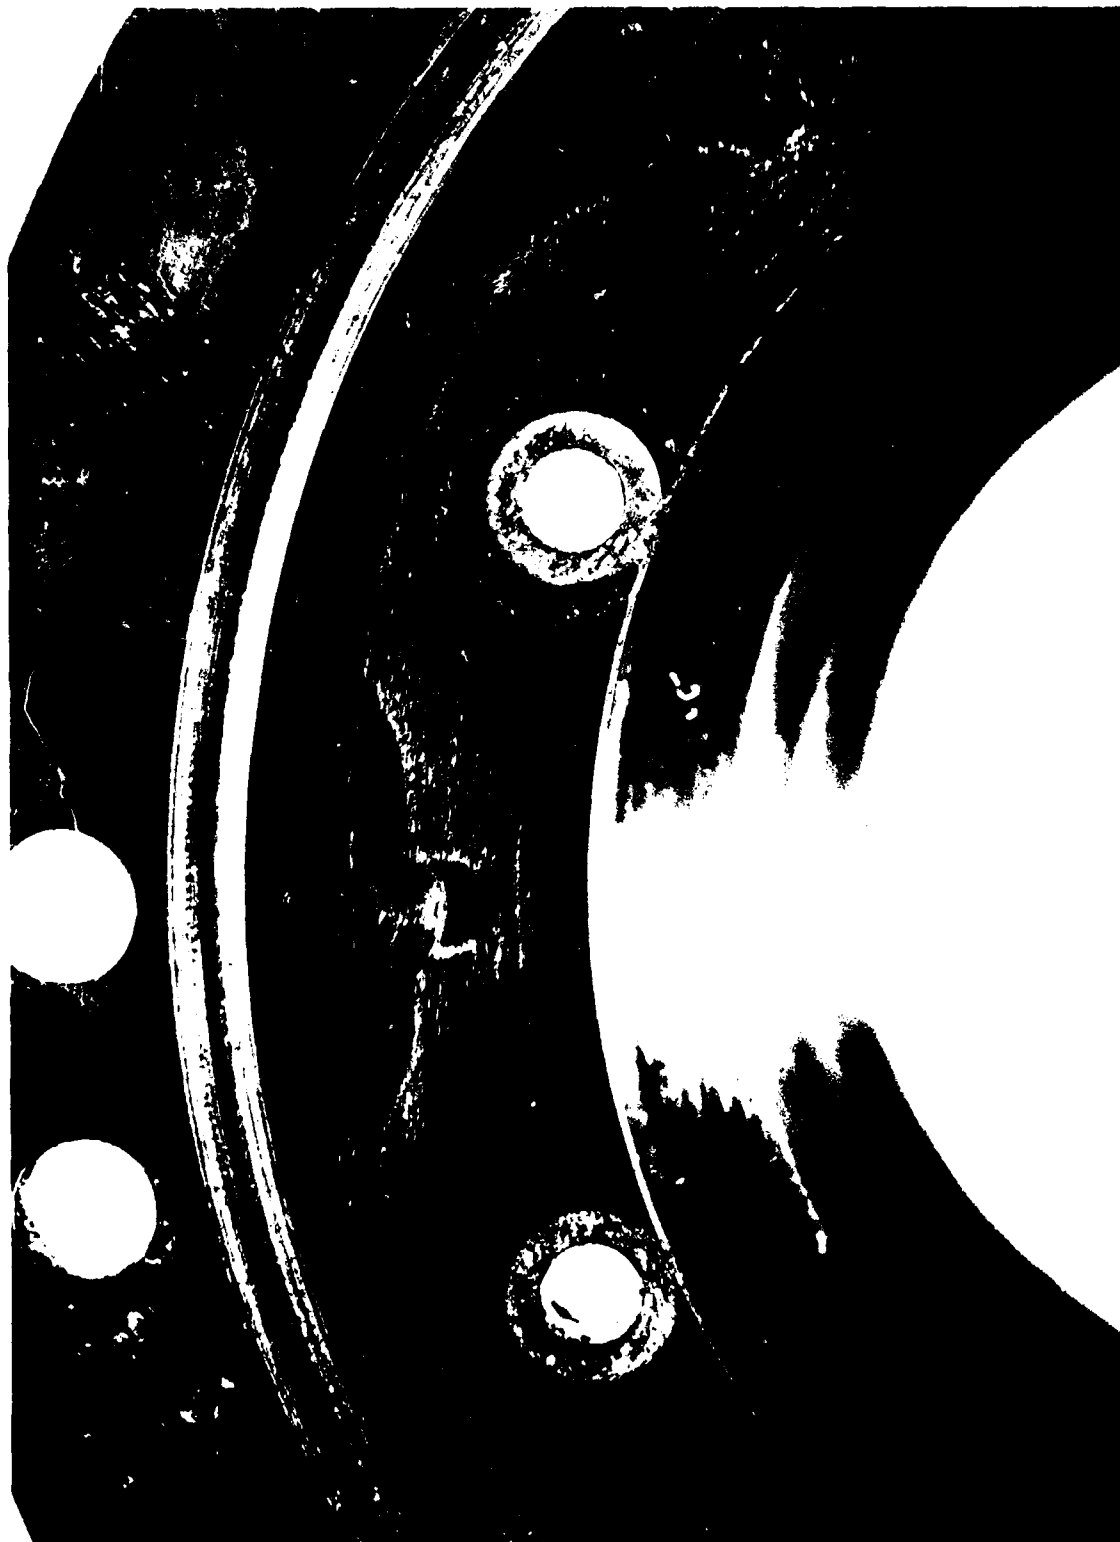
Figure 20. Actuator Housing

At the end of the life test, the actuator was disassembled and inspected. The number one reaction pin spacer, shown in Figures 16 and 17, was broken into four pieces. Reaction pins are shown in Figures 18 and 19. The other reaction pins and other parts of the actuator, as shown in Figures 20 through 23, appeared to be in good condition. The pieces of the broken pin all had sharp edges and showed no sign of being crushed. The magnetic plug was clean after the 50th hour.

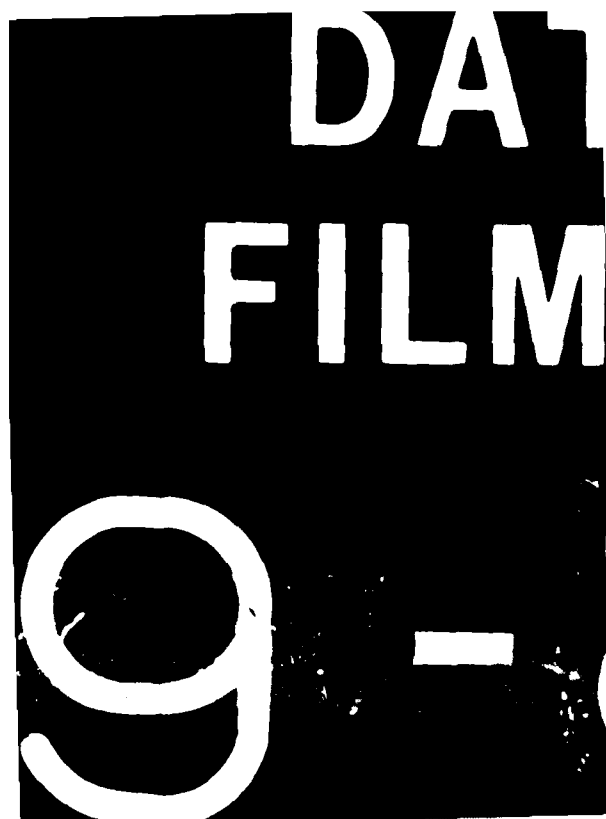
Longitudinal section through a pin spacer which did not fail during the life test, showing neither metallurgical nor manufacturing defect.

Figure 20 con't. Longitudinal and cross sections through one of the provided pin-spacers which sustained the life test with no failure.
